## INVESTIGATION AND CONSERVATION OF A FRAGMENT OF A ROMAN MOSAIC FLOOR FROM THE GOVERNOR'S PALACE OF AQUINCUM (PANNONIA), HUNGARY

BRIGITTA MARIA KÜRTÖSI

The aim of the study of the materials and the structure of this Roman mosaic is to gain thorough information about its technique. The conservation of this fragment made possible the microscopic, chemical and X-ray diffraction examinations, which gave us exact results about the structure and the special technology of the preparation of the support of the mosaic.

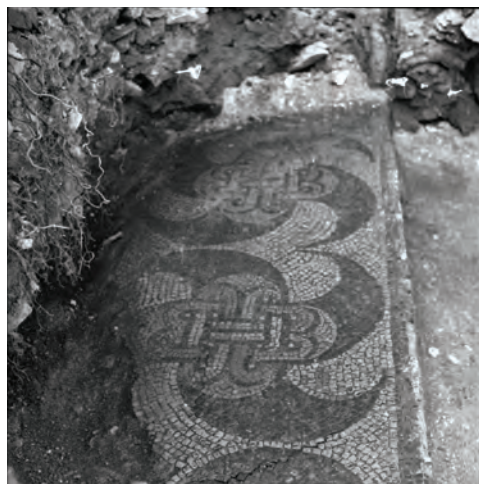
Fig. 1. Archive photo of 1941 showing the mosaic before removal, Óbuda, Hajógyári-sziget. It is clear that in the following years some completions were made as confirmed in János Szilágyi's 1945 publication

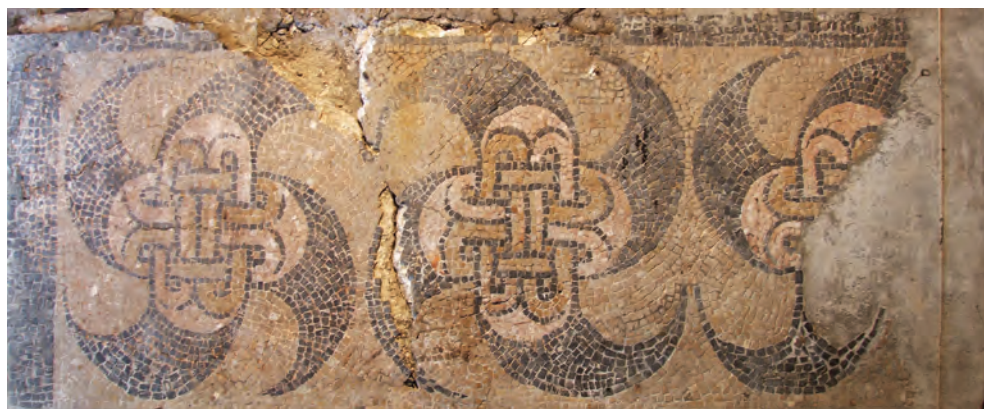
Fig. 3. Condition of the mosaic in 2008 (photo: Brigitta Maria Kürtösi)

– Painting-Conservator (Hungarian University of Fine Arts); consultants: Kriston, László – Physicist (Hungarian University of Fine Arts), Balázs, Miklós Ernő DLA habil – Mosaicist). I studied the materials and the technology of the substrate of the Roman mosaics from Pannonia, and in this case we tried to find a new, lightweight and compatible support for this fragment, while maintaining the surviving original mortar layers. This is the particularity of this restoration because in most cases, after the detachment of the layer of the mosaic tesserae, the removal of the underlying preparatory mortar layers is the general method. Naturally, the weight is the main reason for dealing with it in this way. In our case, however, the thick concrete support had saved these elements. We had to choose the treatments considering both the materials, the stones and the mortars. Therefore, the challenge was to keep them together. The fragment was severely damaged; the salt coming out of the cement and the corroded armature caused cracks not only in the support but in the original mortars too. The fixed, inflexible support was broken,

and this caused loss of tesserae. After the first excavation, it was completed by using concrete on the edges, which often covered the surrounding tesserae. In the central motif, cement was applied to reintegrate losses. Here, not only the tesserae are bigger but also the spaces between the stones are larger and filled with grey cement. In these integrations the original setting aesthetics were not followed. That is why we had to remove these incorrect tesserae fillings. After the systematic removal of the concrete support and the cement fillings, we fortunately found four different fragmentary layers under the mosaic tesserae (Fig. 4 and 5). This offered a good opportunity to examine the technology of the preparation of an 1800-years-old mosaic pavement. It is fortunate that the mortar layers were not destroyed during the rescue excavations like those on the back of the fragments of the other four pavements (Fig. 6). The mortar composition of the layers in question is based on lime. The classical dry lime slaking was employed for the basic mortars. In this case, the dry raw materials are spread and water is poured on them.

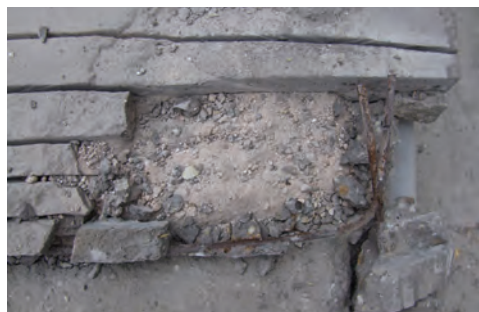
Fig. 5. The remnants of the original mortar layers photographed with oblique lighting (photo: Brigitta Maria Kürtösi)

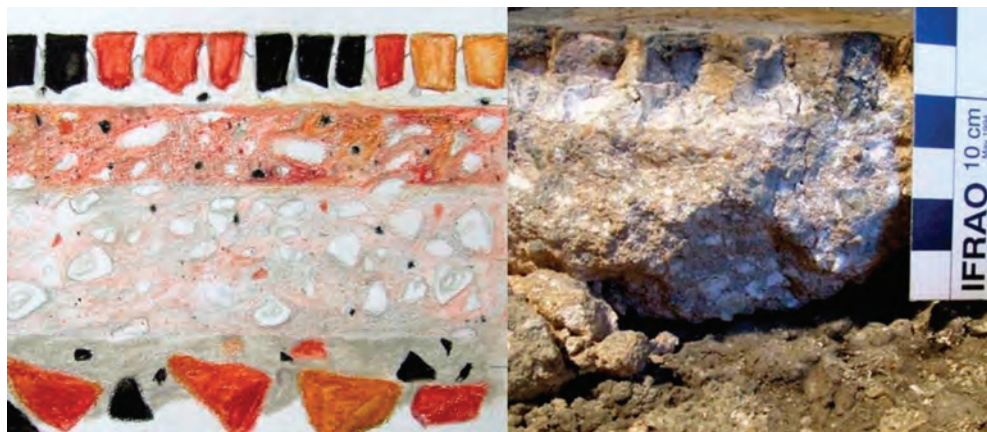
Fig. 6. The stratification of the fragment (Reconstruction drawing and photo: Brigitta Maria Kürtösi)

*Supra nucleus* – This is thin, white bedding mortar. Powder of limestone is present in the lime binder matrix. Based on the microscopic analyses and the X-ray diffraction examination, the sample taken from this layer does not contain any hydraulic additives.

*Nucleus* – There are two layers made 'wet in wet'. The 5 cm thick lower one is richer in lime than the upper 1 cm thick part, where the quantity of powdered brick is significant. That is why this stratum has a pinkish hue. The crushed brick was used as filler. The use of a quantity of brick dust in a mortar can be one of the causes

leading to low density and high effective porosity. It behaves like an artificial pozzolanic additive, and here reacted with the calcium hydroxide  $\text{Ca}(\text{OH})_2$ . As a hydraulic component, it increases the solidity of the mortar. The average porosity value of the samples taken from the *nucleus* of the mosaic in question is approximately 30%, and its density is about  $1.5 \text{ g/cm}^3$ . The other mortar sample comes from the Roman Villa of Serena, in the present-day municipality of Nagyharsány. The characteristic porosity is between 45-50%, and the density is about  $0.6 \text{ g/cm}^3$ .

*Rudus* – Only traces remained of this stratum. It is a rough layer with 4-5 cm large limestone and brick pieces embedded in lime. The materials and the colours of these parts are the same as those of the tesserae.

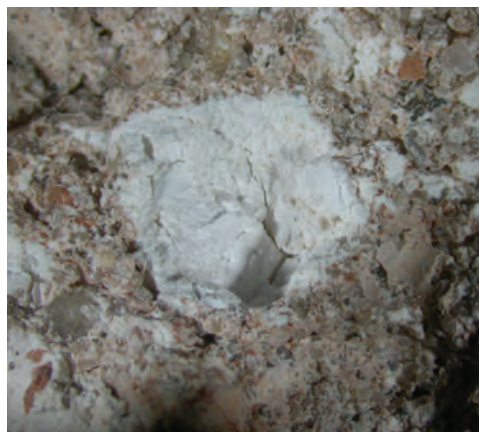
Fig. 7. 'Kalkspatzen' - detail of the first layer of *nucleus* (Photo: Brigitta Maria Kürtösi)

The slaking of the quicklime happens on the premises. The presence of chalk-like kernels in the lime, called 'Kalkspatzen' in German, is quite extensive. These kernels are reserves of binder and can be activated by moisture. The binder obtained from them migrates and can bind the micro-cracks all over the matrix of the preparatory mortar layers (Fig. 7). The traditional division of the preparatory layers can be found in this mosaic:

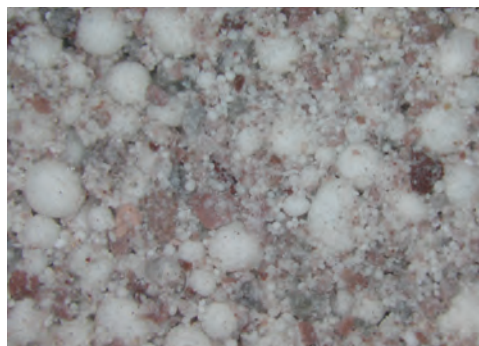
Fig. 8. The new lime-based mortar with light-weight aggregates (glass foam products) (Photo: Brigitta Maria Kürtösi)

During conservation, we had to save the original preparatory mortar, so we were dealing with quite a heavy object. After the cleaning of the reverse side, we had to fill in and level the mortar surface. It was necessary to work out a lightweight and easily removable support, instead of the previous concrete one, and a lightweight lime-based mortar to fill in the losses. Instead of the quartz sand and crushed gravel, a mixture of ground glass foam (a Hungarian product by Geofil) and glass foam-beads (Poraver by Dennert) were used as filler (Fig. 8). The diverse grain-size dispersion ensures a properly stable mortar. The pH value of Poraver is about 9-12. The cause of this high pH value is the presence of a water soluble salt called Trona ( $\text{Na}_3\text{H}(\text{CO}_3)_2 \cdot 2\text{H}_2\text{O}$ ) measured by XRD. It was necessary to re-

move the salts before using the glass foam-beads as filler in the new mortar. For the backing we tried to use clear, inorganic materials. The mortar supplement had to be easily removable; and had to fit in with the original materials and their physical properties. At the same time, it is not supposed to be stronger than the ancient mortar. It is desirable that the effective porosity of the two touching layers be similar. In this case, the measured values were about 30%. The difference was between the density values as the used fillers halved the density of the new mortar (Table 1). In this case, the filling mortar has a mainly supporting role; thus, it must be lightweight and stable. Its stability increases with the process of carbonation. The new support is a composite

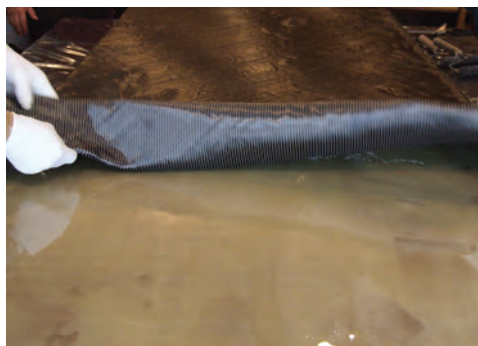
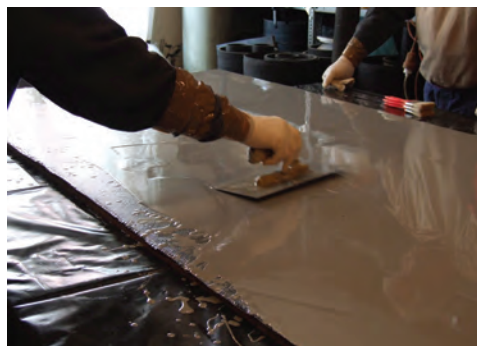
Fig. 9. The preparation of the new support with woven carbon fibre and 3PSP2 resin (Photo: Brigitta Maria Kürtösi)

Fig. 10. The preparation of the new support with woven carbon fibre and 3PSP2 resin (Photo: Brigitta Maria Kürtösi)

plate made of a foam glass board (by the German Huber-Kunststoff) covered with 3P SP2 resin (by the Hungarian Polinvent Ltd.) and woven carbon fibre on both sides (Fig. 9-12). These materials were developed for industrial use. That is why it was necessary to understand their physical properties before introducing them into conservation. The artwork was fixed onto the foam glass board with acetate-free silicone rubber. As bedding mortar, a Czech grouting mortar was used (VAPO inject 01), because its composition and properties resemble those of the original. The mixture consists of white, hydraulic and volumetrically stable lime-hydrate, mixed with latently working hydraulic fired clay – alumino-silicate component. The filling in of the pattern was made with tesserae from a geologically similar limestone. The original and the completed parts show a mild difference in their hue. The extent of the completion does not exceed the provable original state of the mosaic (Fig. 13, 14 and 15). There are many types of completion methods, and the choice of materials and treatment is most often based on the personal preferences of the conservator, and on the owner's decision.

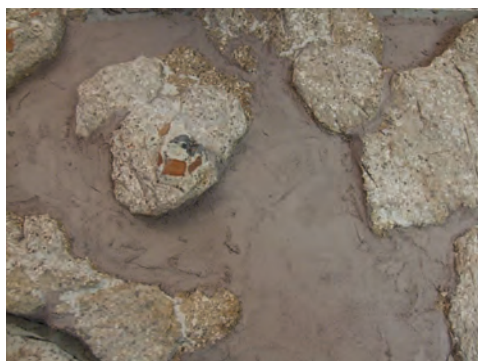
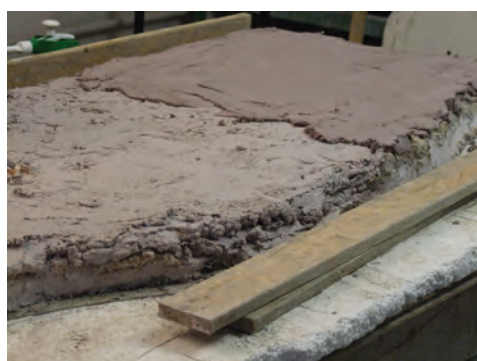
Fig. 11. The leveling of the backside of the mosaic was made by the lightweight lime-based mortar (Photo: Brigitta Maria Kürtösi)

Fig. 12. The leveling of the backside of the mosaic was made by the lightweight lime-based mortar (Photo: Brigitta Maria Kürtösi)

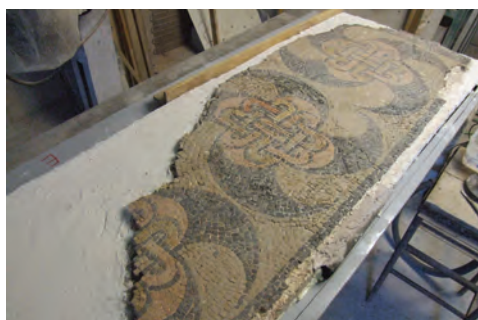
Fig. 13. The place of the missing parts (Photo: Brigitta Maria Kürtösi)

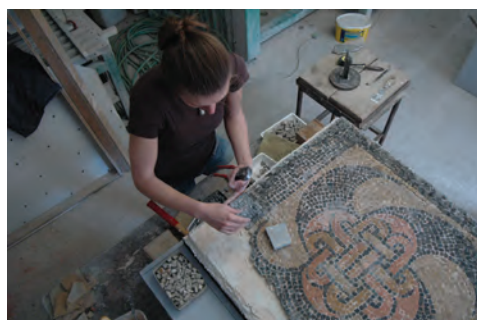
Fig. 14. The preparation of the new tesserae supplements (Photo: István Bóna)

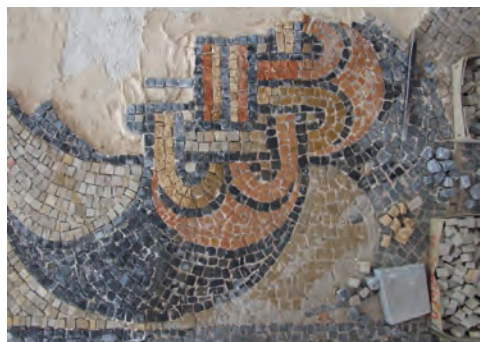
Fig. 15. The material of the new tesserae supplements was a geologically similar massive limestone. The lime-based VAPO inject 01 was used as bedding mortar (Photo: Brigitta Maria Kürtösi)

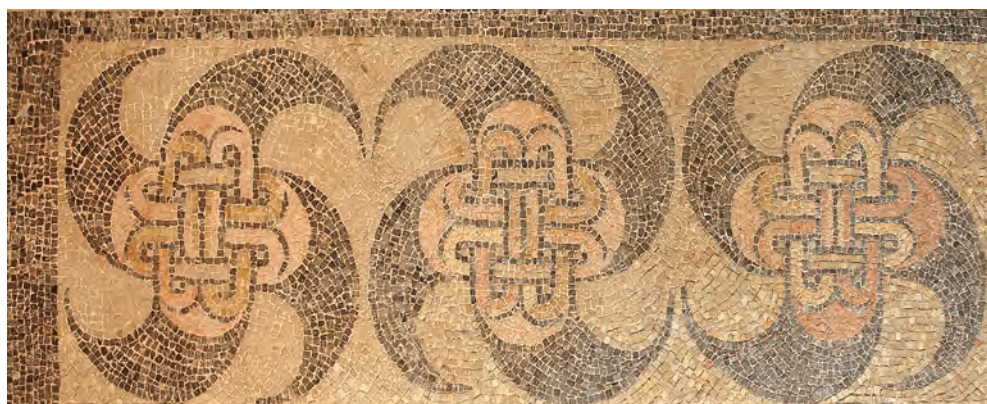
Fig. 16. The state of the threshold mosaic after conservation in 2010 (Photo: Brigitta Maria Kürtösi)

um, and then at the temporary exhibition of the Museum of Aquincum entitled *There is something new under the ground, old sites – new results 2011* (Fig. 16).
