## CHALLENGES AND RISKS OF THE RE-RESTORATION OF A TURN-OF-THE-CENTURY GLASS MOSAIC

BRIGITTA MÁRIA KÜRTÖSI, HUNGARIAN UNIVERSITY OF FINE ARTS, CONSERVATION DEPARTMENT, BUDAPEST, HUNGARY,  
kurtosi.brigitta.maria@gmail.com

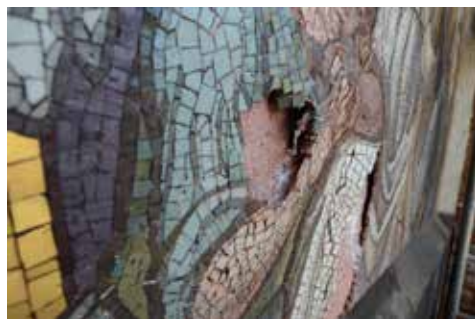
The lunette mosaic decorates the entrance of the Fasori Lutheran Church in Budapest. In the past, a nearly vertical structural crack was generated and appeared on the surface of the mosaic. The continuous soaking of the porticus structure kept active the salt movement and caused damages and losses in the unity

Fig. 1. Deformations and losses of the mosaic before application of the emergency facing, 2018 (photo by B. M. Kürtösi)

of the mosaic (Fig. 1). The previous operations cannot solve the problem but accelerated it.

The Church was afraid to lose the mosaic and tried to find solution. We agreed that in this case only the detachment of the mosaic will surely help. Unexpectedly, an unknown coating was found on the surface during our emergency treatment (Kürtösi 2019). A not mentioned but previously used hydrophobic layer on the glass tesserae made practically impossible to execute any urgently needed treatments. Despite many cleaning attempts performed on test samples

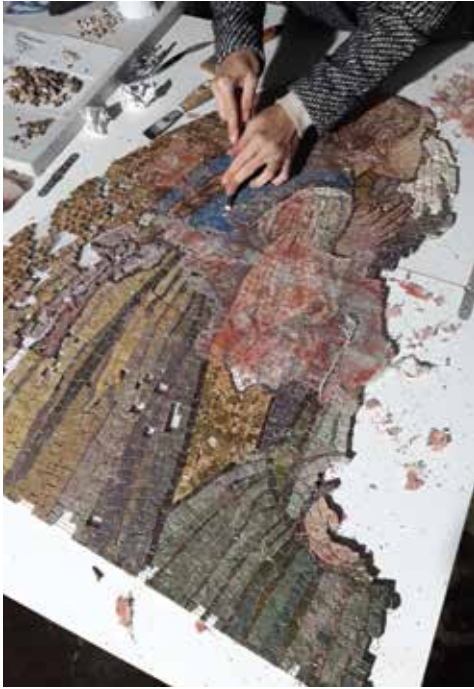
Fig. 2. Mechanical removal of the silicone facing after the application of the new backing system (photo by B. Dohárszky)

The mosaic sections were transported to the workshop where a new backing system was developed and applied (Kürtösi 2021) before the mechanical cleaning (Fig.2). Firstly, fiberglass mesh was fixed on the backside of each section with a transparent MS polymer (modified silane polymer). The MS polymer consists of a polyether main chain end-capped with methylmethoxysilane groups (Petrie 2010). By this modification it differs from the silicones, which let it well applicable in this special case during treatments on the surface and on the back as well.

The 21 detached sections along with the reconstructed part were mounted on a new, lightweight, and flexible support, on a 1.6 cm thick polycarbonate panel by using the author's newly developed intermediate layer composed by the MS polymer filled with extruded polystyrene foam (XPS) filings. Before the realisation, model trials were performed to be sure about the nature of the layers prepared. After the

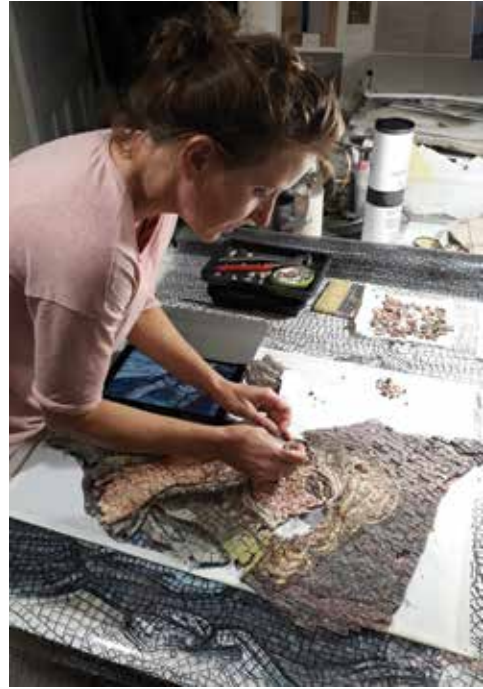
Fig. 3. Indirect reconstruction process of the missing and incorrect part of the composition (photo by B. Dohárszky)

The method was similar to the original, the indirect version of the setting which can help to create a smooth surface which is significant in the characteristic appearance of the mosaics from the period. Be-

fore the process the mosaic was graphically documented tessera by tessera on PVC foil, which was useful during this part of the work to be able to fit the tesserae again in a proper connection with the surrounding mosaic details (Fig. 3).

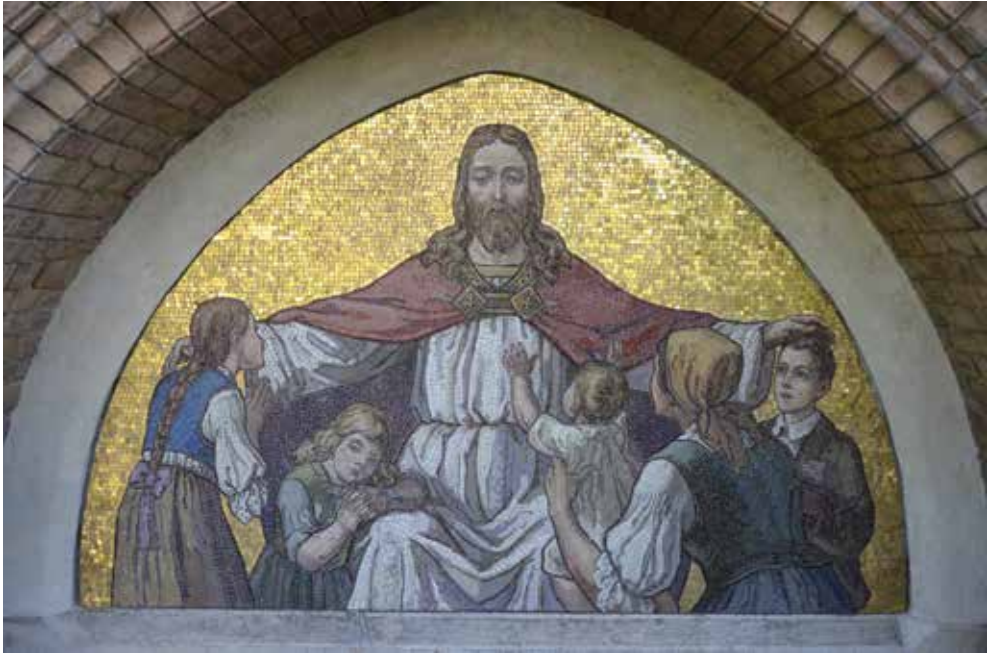
Fig. 4. The view of the mosaic on the spot after detachment, restoration, and reinstallation (photo by B. M. Kürtösi)

On the site the mortar layers were removed and the mosaic on the new support was fixed its original place by screwing. It was important feature to leave space behind and around the panel for the air and moisture circulation.

The mosaic preserved its qualities in appearance, but it is fixed separately from its original support, the building façade, thus it has no more direct connection with the wall and the 2.7 cm thick new system was suitable to place it in the original position (Fig. 4).
