# INVESTIGATION OF *IN SITU* REGENERATION POSSIBILITIES OF CARTELLINE IN CASE OF MODERN GOLD GLASS TESSERAE

BRIGITTA MÁRIA KÜRTÖSI, HUNGARIAN UNIVERSITY OF FINE ARTS, CONSERVATION DEPARTMENT, BUDAPEST, HUNGARY,  
kurtosi.brigitta.maria@gmail.com

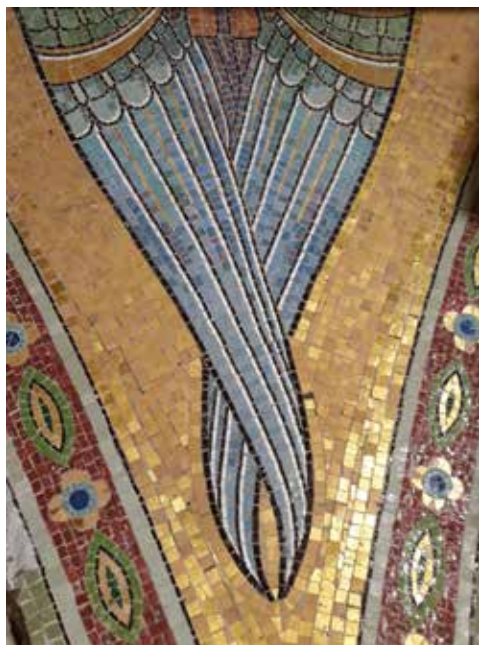
Fig. 1. Altered, randomly located gold leaf tesserae *in situ*. of mosaics in the dome and the pendentives by Zsigmond Vajda and Miksa Róth. In 1904. South-Eastern dome of the Archways by Lajos Gerle in the Fiumei Road National Cemetery, Budapest (photo by B. M. Kürtösi)

Under the same conditions some tesserae are in normal, general state, but some of them – which can be randomly located – are completely altered (Fig. 1).

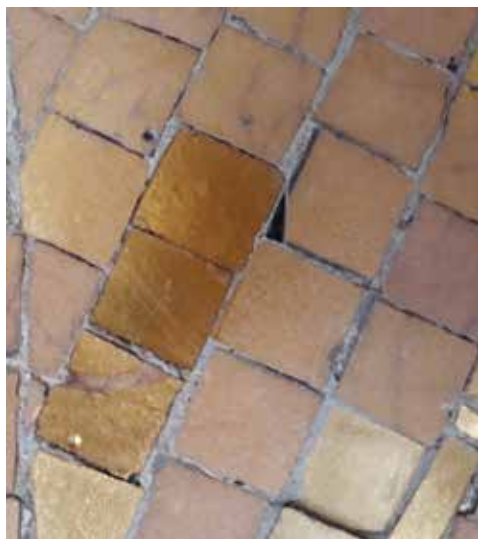
Fig. 4. Three of the altered tesserae treated on the spot (2019) (photo by B. M. Kürtösi)

Not only as a glue as it is in use mainly in the glass and ceramic conservation practice, but as a coating it may be a solution according to the actual results of the ongoing research. The on-site testing (Fig. 4) executed parallelly with the conservation works stopped in 2019 and waiting for the continuation.
